Mountain View  
Whisman  
School District

MVWSD MASTER FACILITIES PLAN

November 2019

# Mountain View Whisman School District Roof Assessment

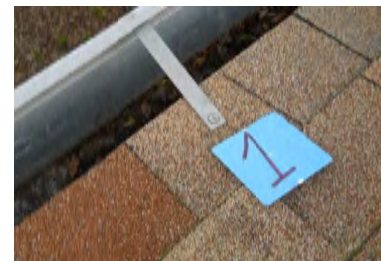
Typical Deficiency - Gutter brackets have been face fastened through asphalt shingle. Recommend removal and repositioning bracket. Repair asphalt shingles as needed.

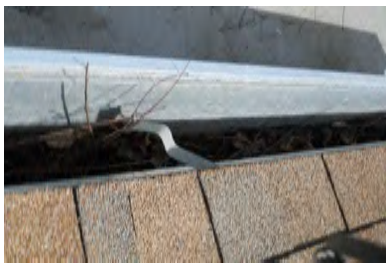
Typical Deficiency - Gutter straps need to be re-fastened.

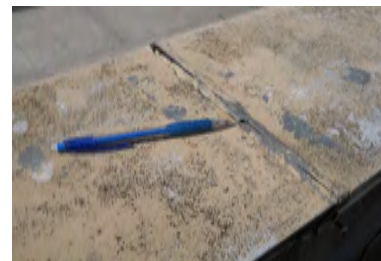
Typical Deficiency - Observed accumulation of debris at field of roof. Recommend clearing debris from all gutters, drains, waterways, and field of roof to promote positive drainage.

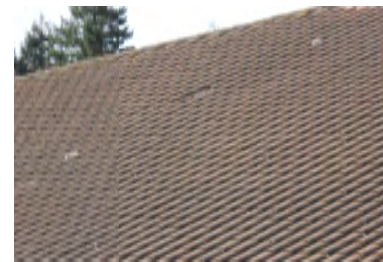
Typical Deficiency - Missing concrete S tile.  
Recommend replacement of all missing and or damaged tiles.

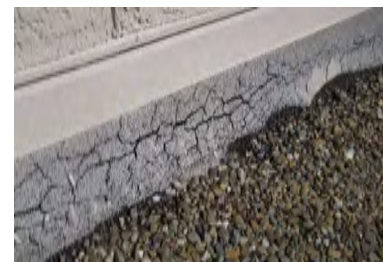
Typical Deficiency - Base flashings show signs of deterioration and cracking. Recommend application of silicone or acrylic coating to maximize usable life of existing built-up roof system.

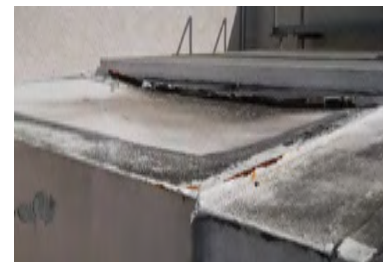
Typical Deficiency - Mechanical duct work damaged and deteriorated. Recommend replacement of damaged duct by licensed mechanical contractor and coating with acceptable silicone or acrylic coating.

Recommend tear off of existing roofing and installation of new BUR roof system. Recommend additional evaluation of mechanical duct for repair and or replacement.

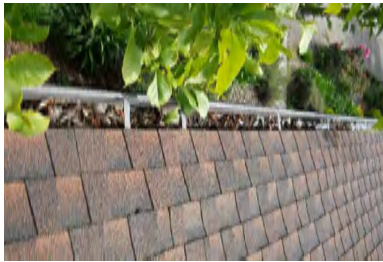
Typical Deficiency - Gutters are full of debris. Recommend clearing debris from all gutters, drains, waterways, and field of roof to promote positive drainage.

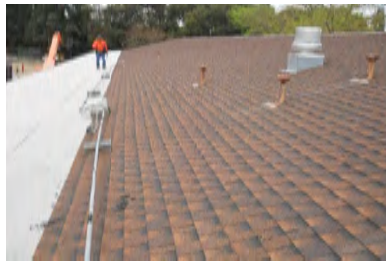
Typical Deficiency - Through roof penetrations do not appear to have proper roof jack. Recommend installing proper roof jack and storm collar.

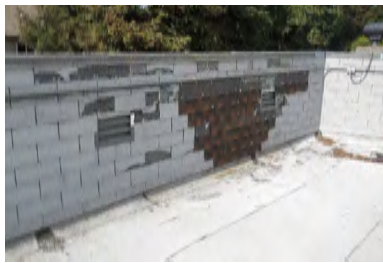
Typical Deficiency - Asphalt shingles are damaged and missing. Recommend replacing.

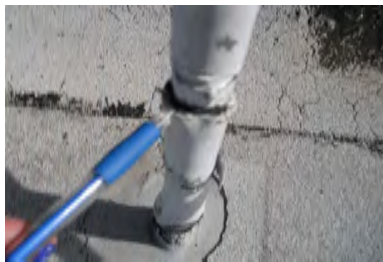
Typical Deficiency - Through roof penetration has not been properly sealed. Recommend re-sealing and installing storm collar.

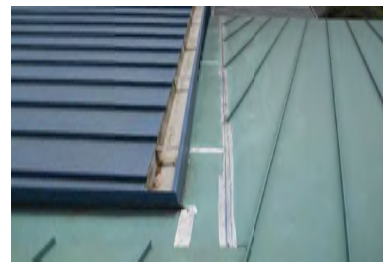
Typical Deficiency - Roof transition/ cricket has been temporarily sealed. Recommend removal of all temporary repairs and installation of as needed permanent repairs.

Remove all debris from field of roof, drain assemblies, gutters, and waterways.  
 Repair incomplete details and open roof transitions.  
 Install stainless steel band clamps and storm collars as needed.

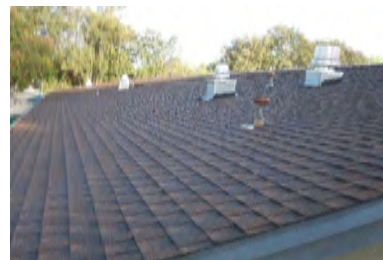
Roof Overview - Building 3

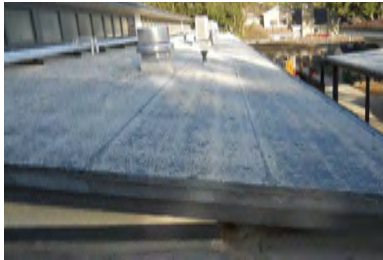
Roof Overview - Building 3 and 4 Similar

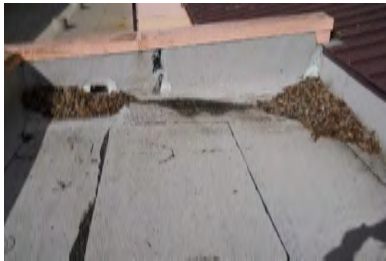
Typical Deficiency - Debris have accumulated at field of roof. Recommend clearing debris from all gutters, drains, waterways, and field of roof to promote positive drainage. Through wall scuppers should have debris screens. Recommend installation of gutter screens to promote positive drainage.

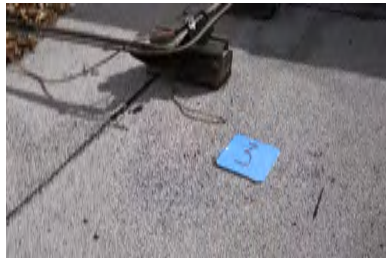
Typical Deficiency - Mineral surfaced cap sheet has blistered. Recommend relief cutting blister, imbed in layer of modified mastic, and apply target sheet of mineral surfaced cap sheet in cold applied adhesive.

Repair blistered membrane.

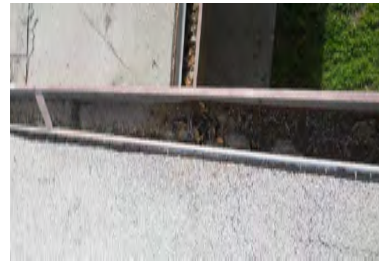
Typical Deficiency - Gutters are full of debris. Recommend clearing debris from all gutters, drains, waterways, and field of roof to promote positive drainage.

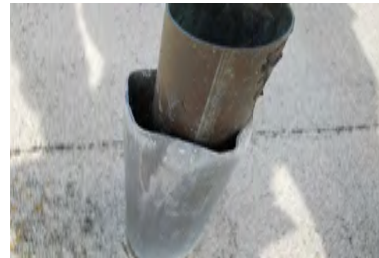
Typical Deficiency - Pipe jacks are missing sealant. Recommend application of flexible flashing self-adhered tape and or sealant, and install storm collar.

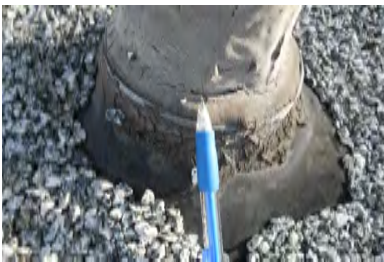
Typical Deficiency - Detailing at through roof penetrations show signs of cracking and delamination. Recommend touch up of mastic at penetrations and application of acrylic or silicone coating to preserve and maintain repair.

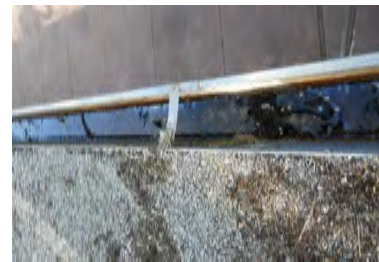
Typical Deficiency - Gutters are full of debris. Recommend clearing debris from all gutters, drains, waterways, and field of roof to promote positive drainage.

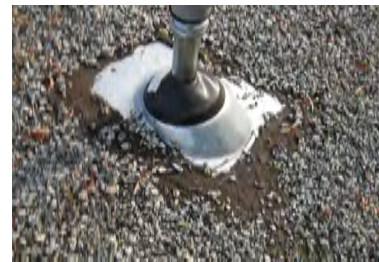
Typical Deficiency - Through roof penetrations do not appear to have proper roof jack. Recommend installing proper roof jack and storm collar.

Remove and replace incorrect roof jacks.

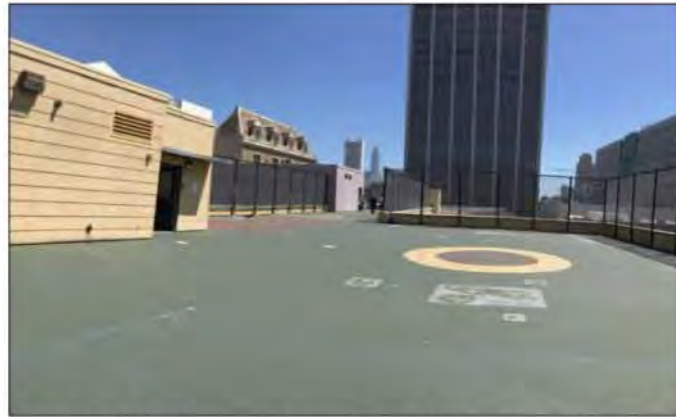
Rooftop Play Area at Level 4 with Storage and Stairs

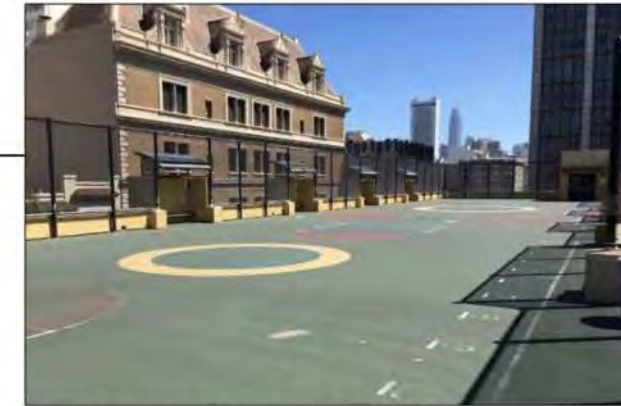
Rooftop Play Area at Level 4

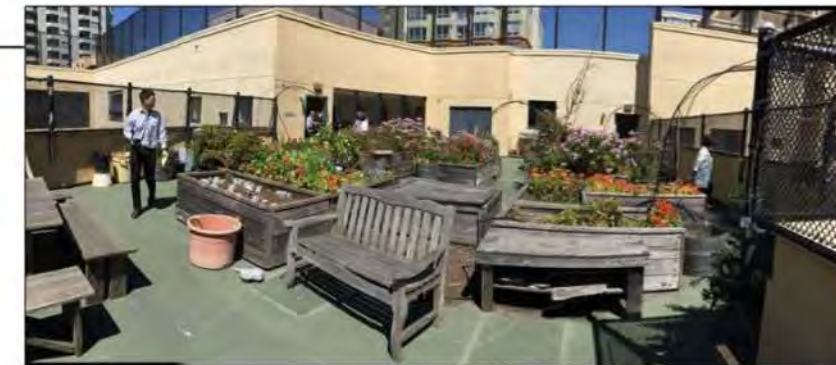
Community/Faculty Garden on Rooftop at Level 3

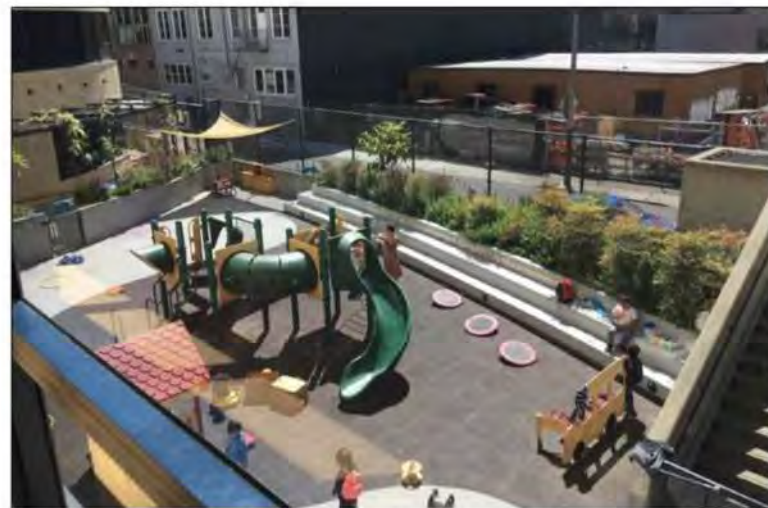
Preschool Play Area on Ground Level (over Basement)

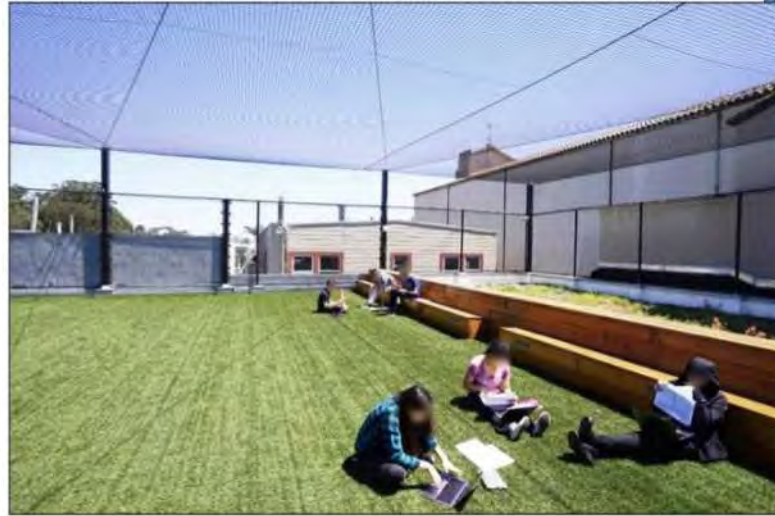
**Rooftop Play Area with Field Turf, Green Roof, and Netting**

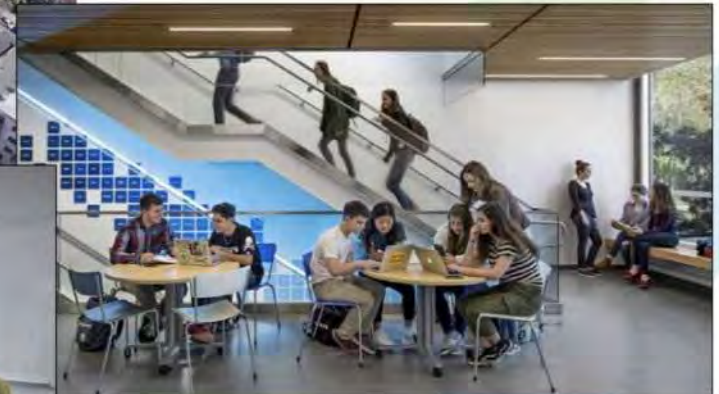
**Upper Level Informal Student Gathering Spaces overlooking Gym**

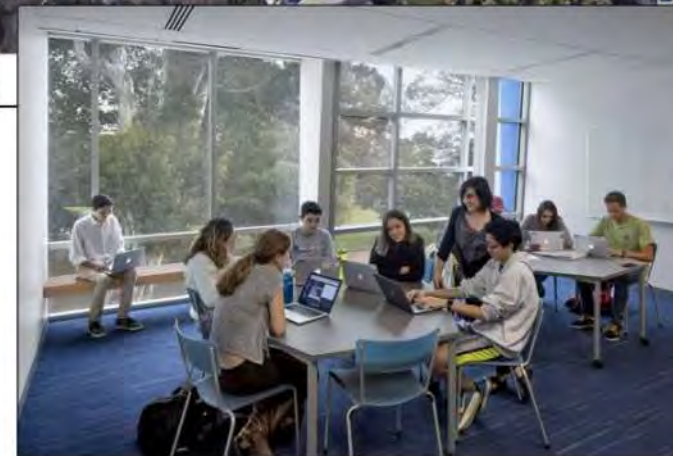
**Upper Level Classrooms and Informal Student Gathering Spaces overlooking Park**

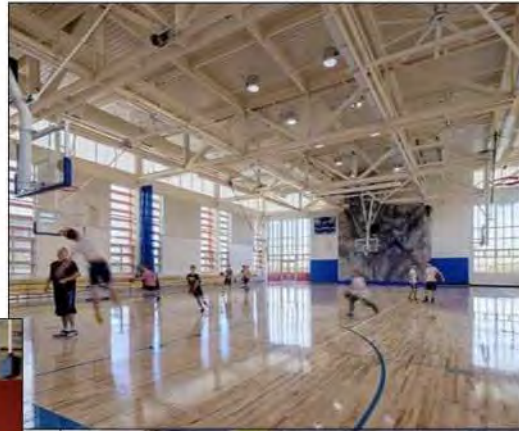
Upper Level Gym with Extensive Daylighting

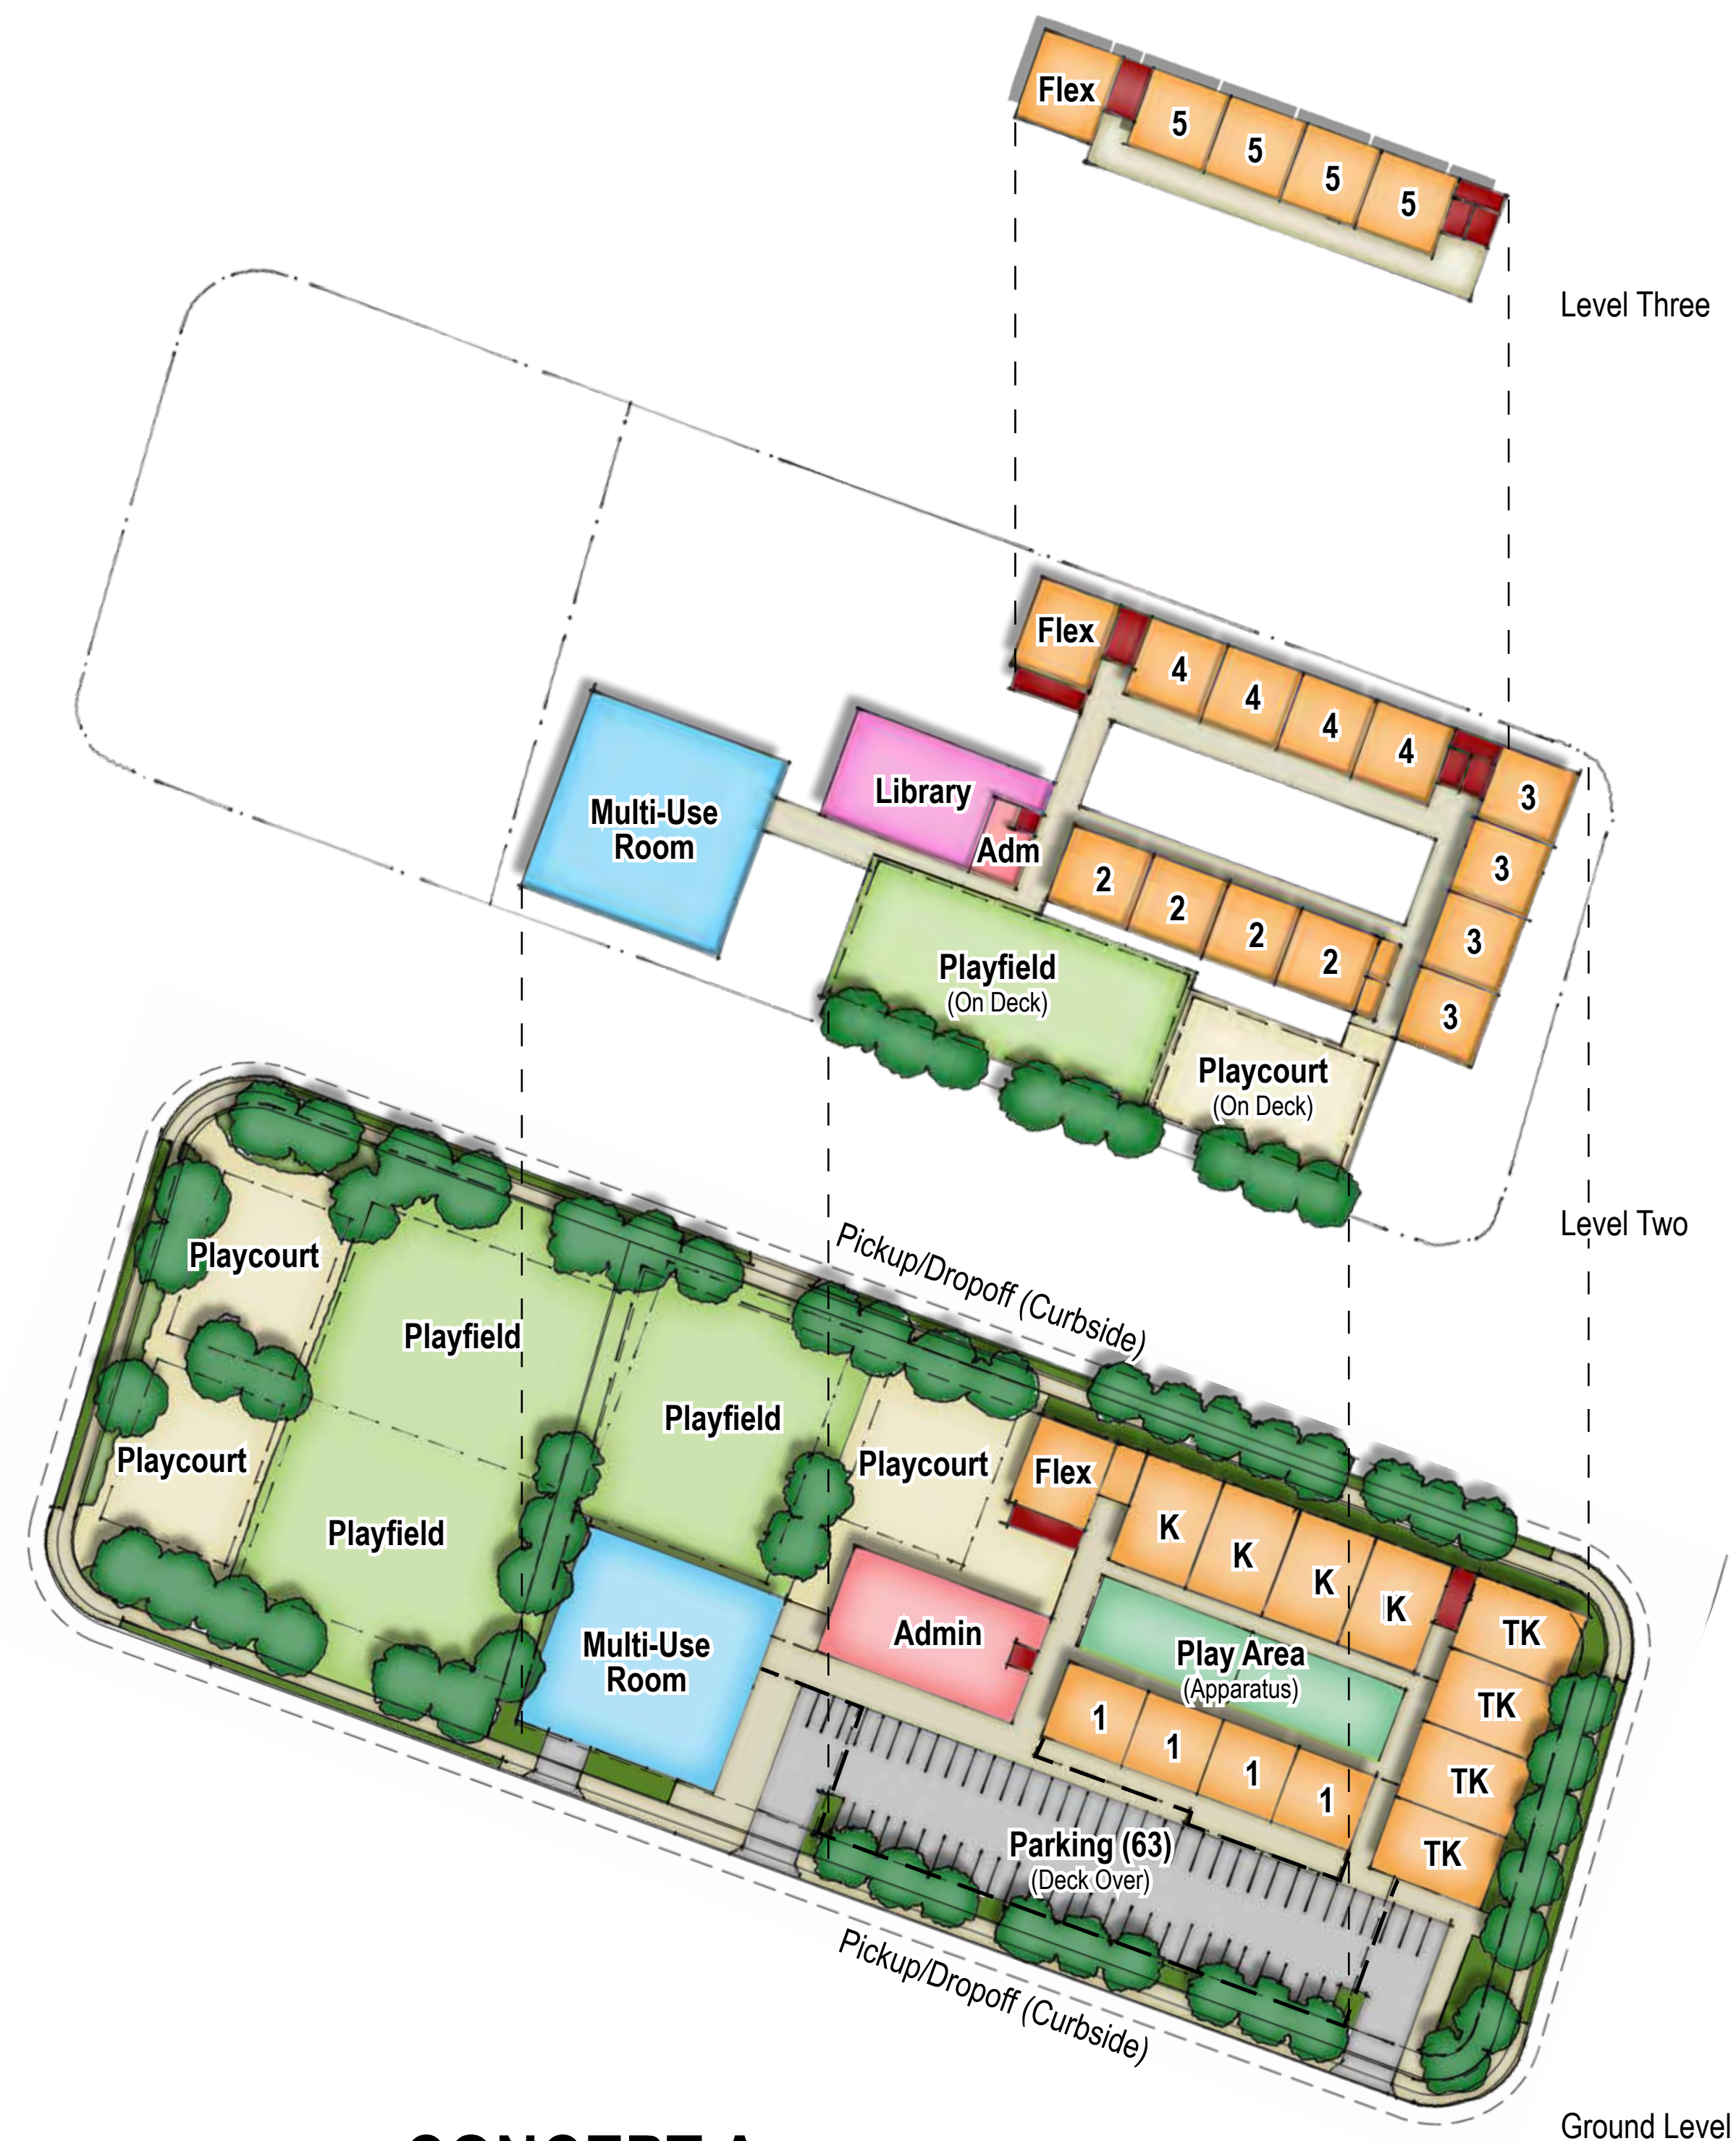
**CONCEPT A**  
**North Bayshore Elementary School**  
 2.5-3.5 acres, 1500-1550 Plymouth St., Mountain View, CA

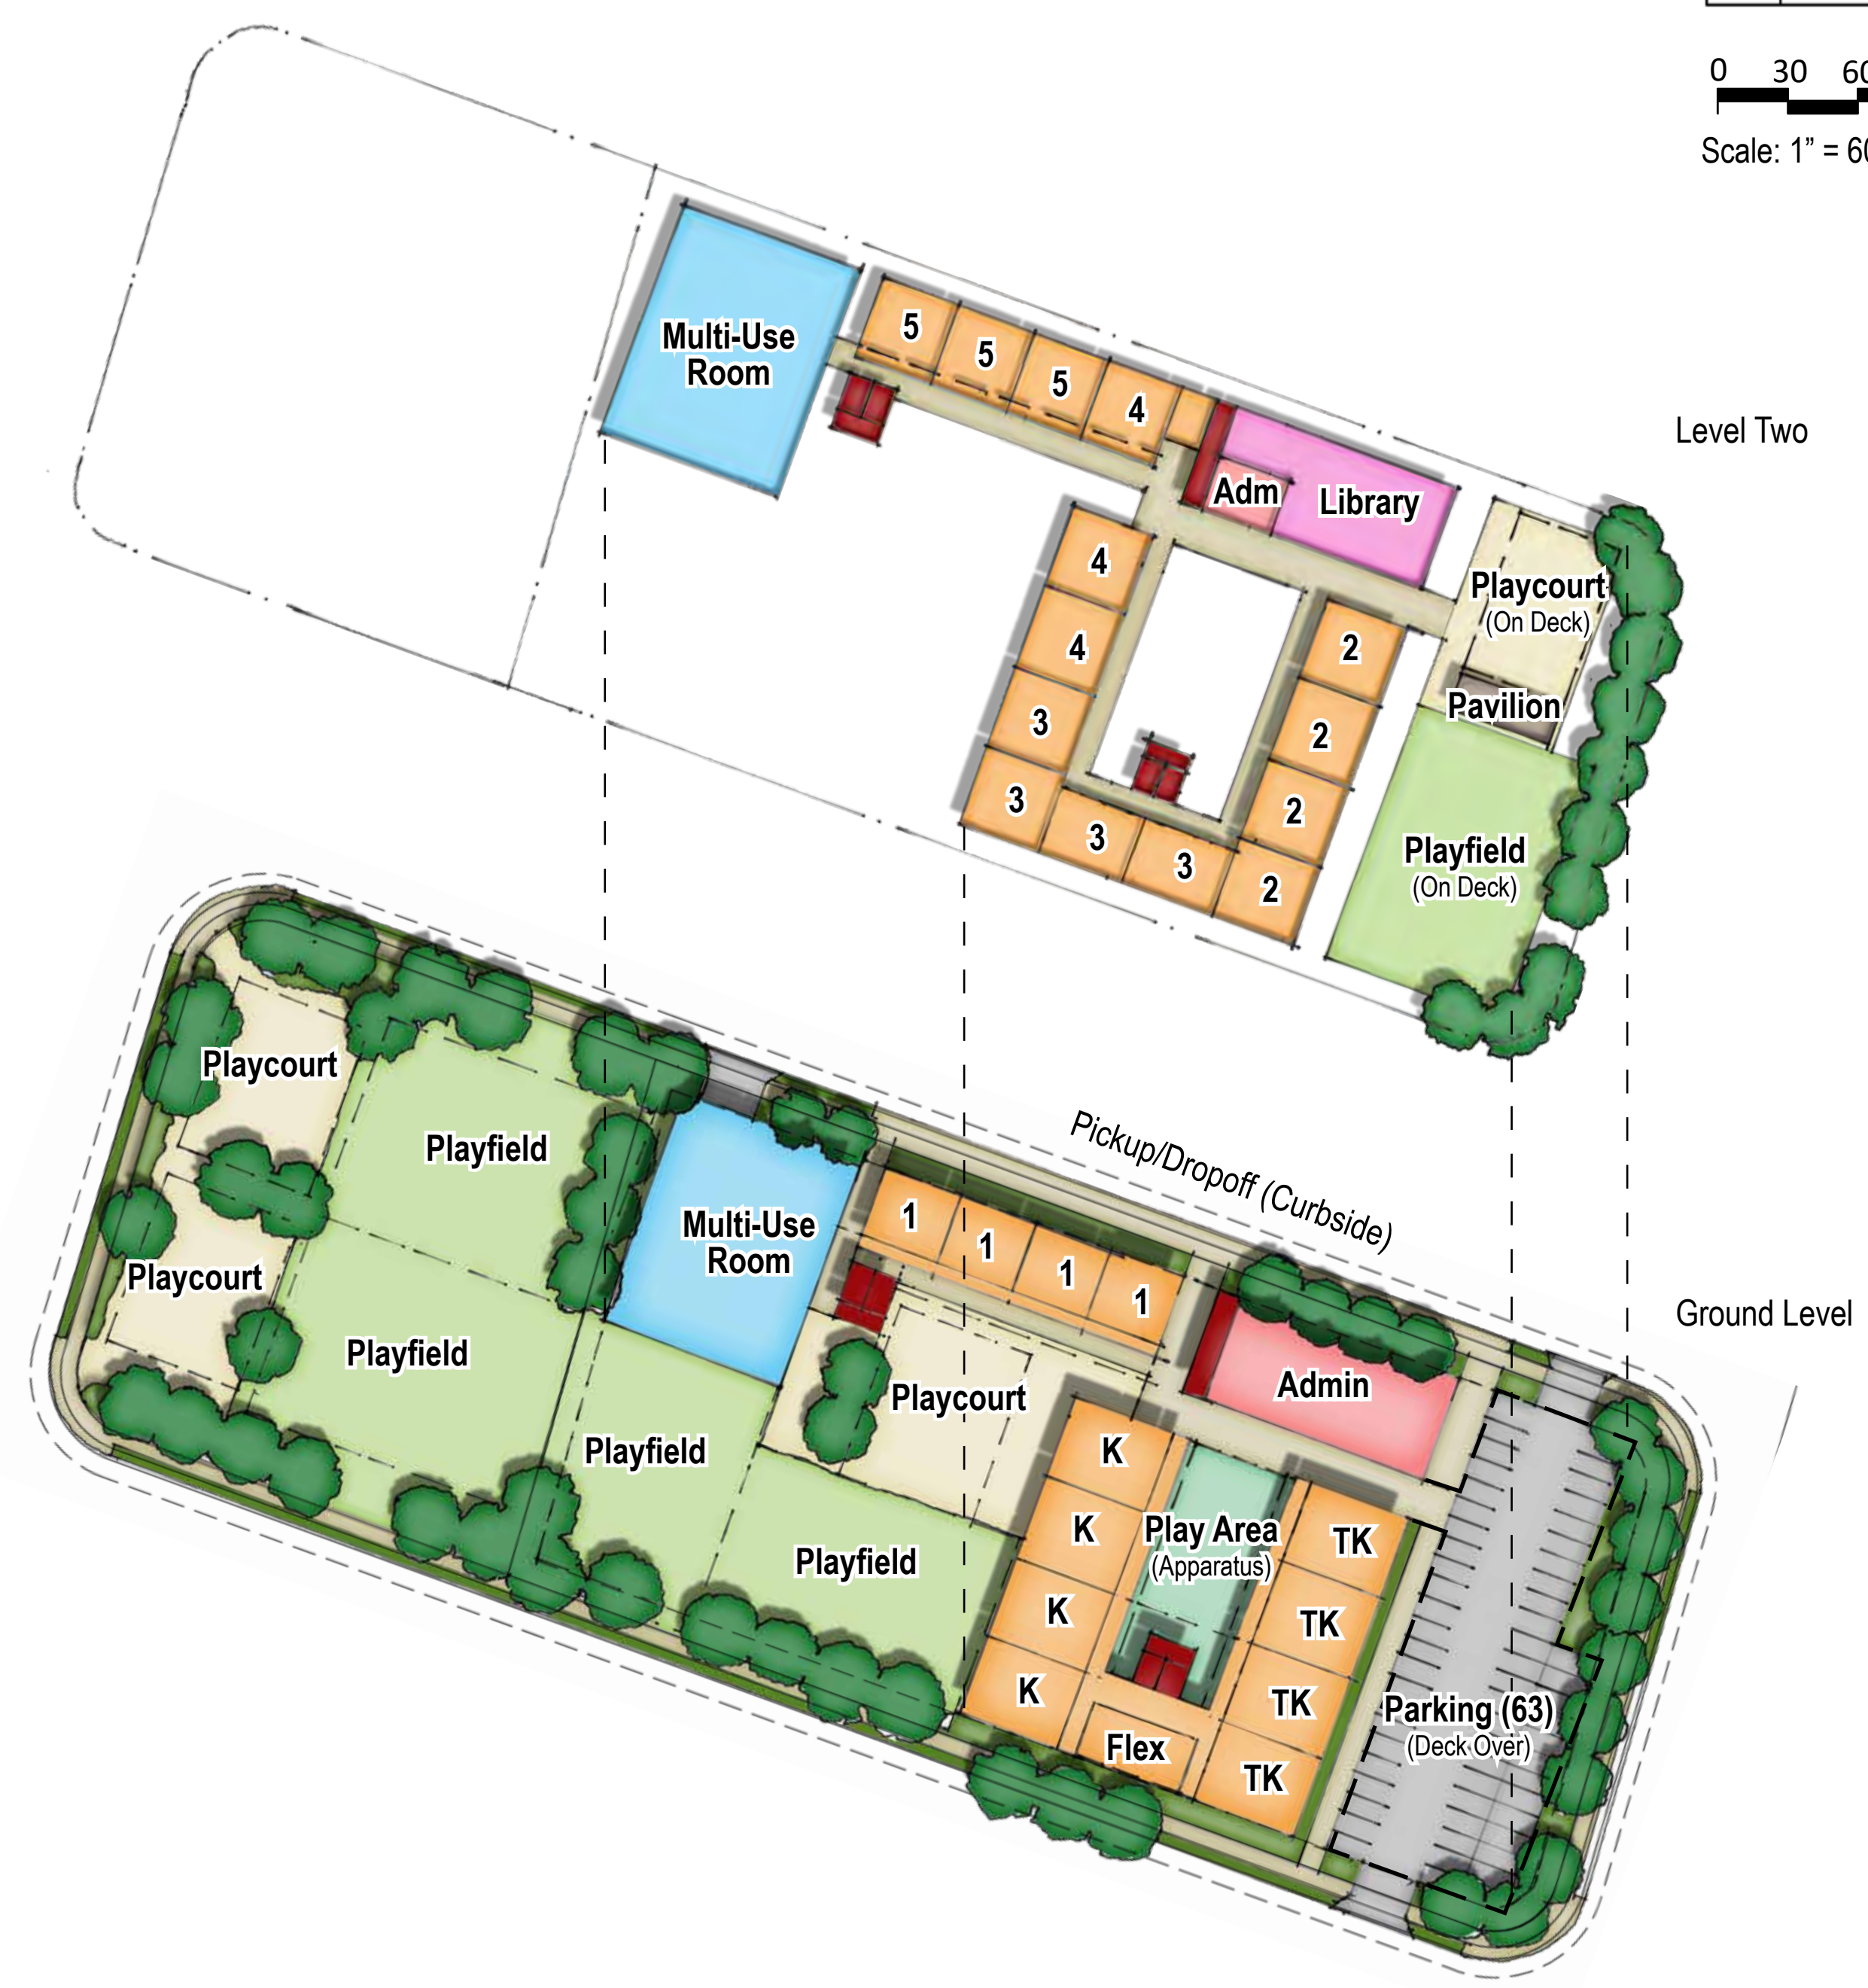
**CONCEPT B**  
**North Bayshore Elementary School**  
 2.5-3.5 acres, 1500-1550 Plymouth St., Mountain View, CA

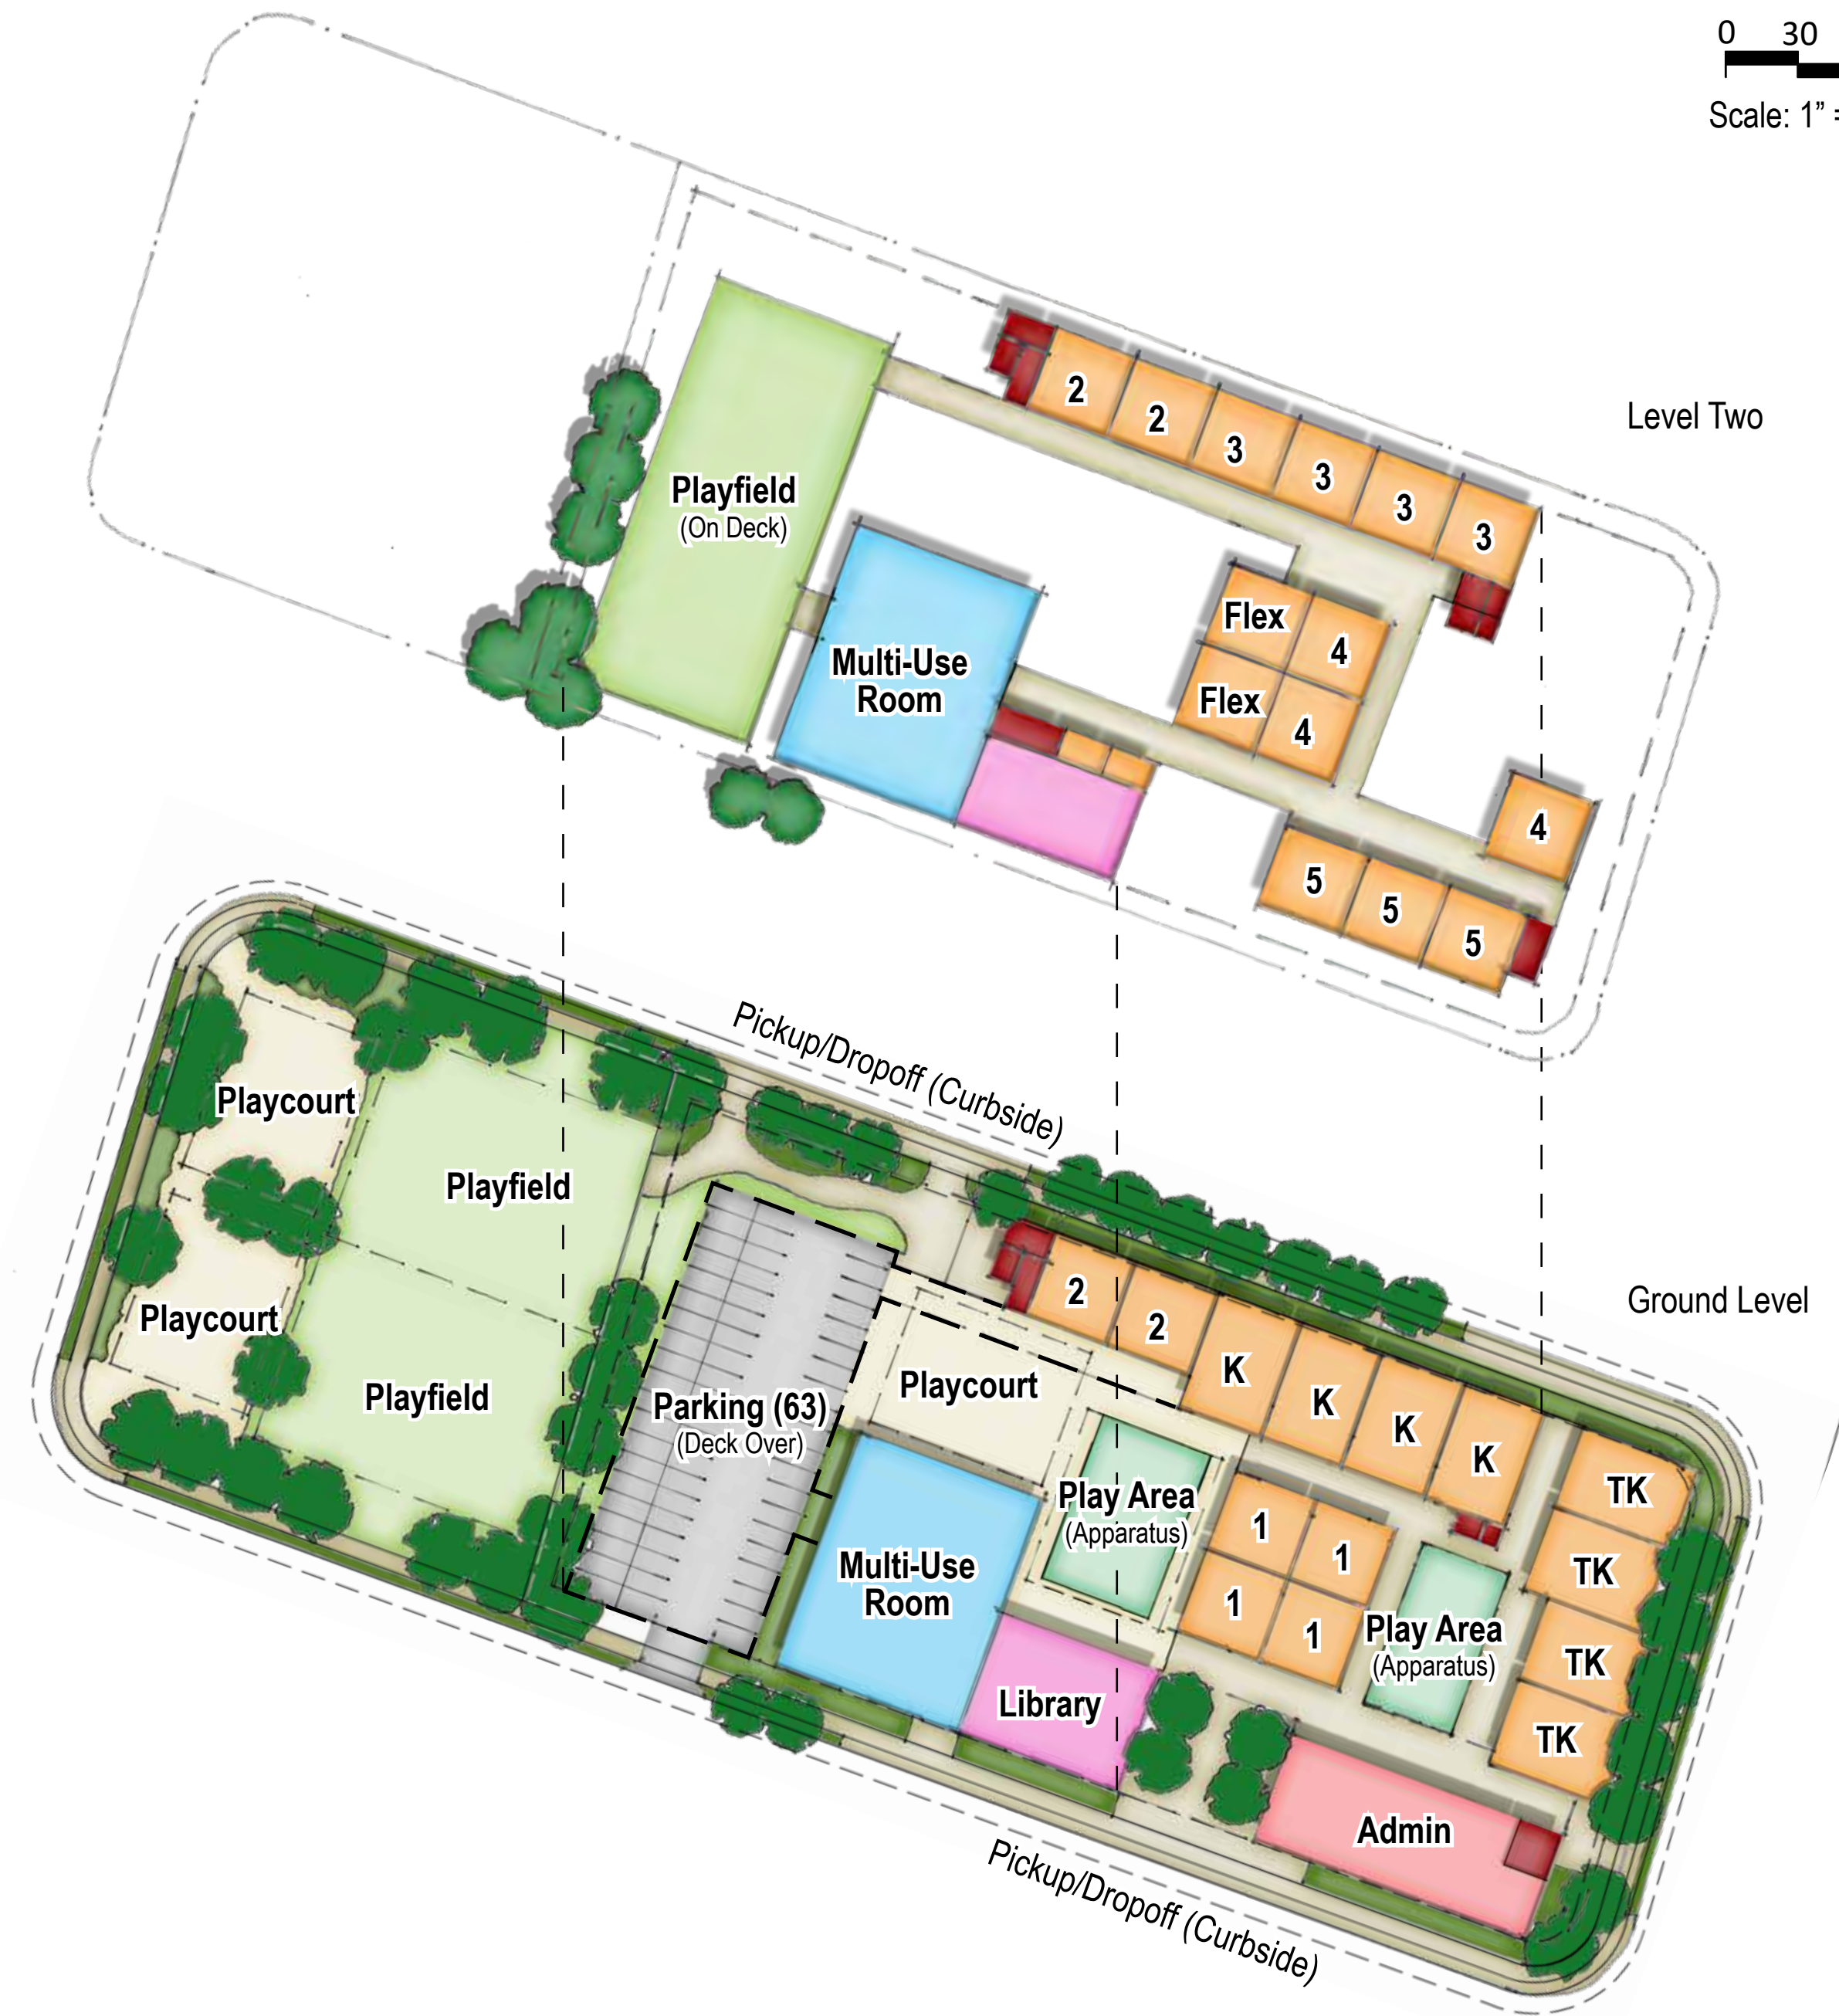
**CONCEPT C**  
**North Bayshore Elementary School**  
 2.5-3.5 acres, 1500-1550 Plymouth St., Mountain View, CA
